Surveyor I

Surveyor I, first of a series of seven soft-landing spacecraft to be launched to the Moon during 1966 and 1967, was designed and built for the National Aeronautics and Space Administration by Hughes Aircraft Company under contract to the Jet Propulsion Laboratory. JPL is responsible to NASA for the direction of Surveyor Project. It was launched on May 30, 1966, from Cape Kennedy, Florida, by an Atlas/Centaur launch vehicle, built for the Air Force and NASA's Lewis Research Center by the General Dynamics Corporation. Surveyor's television camera was capable of operating at two focal lengths: 100-millimeter, narrow-angle, 6-degree field of view and 25-millimeter, wide-angle, 25-degree field of view. Its two scan modes were a 200-line and a 600-line format. (All photographs in this set are in 600-line format.)

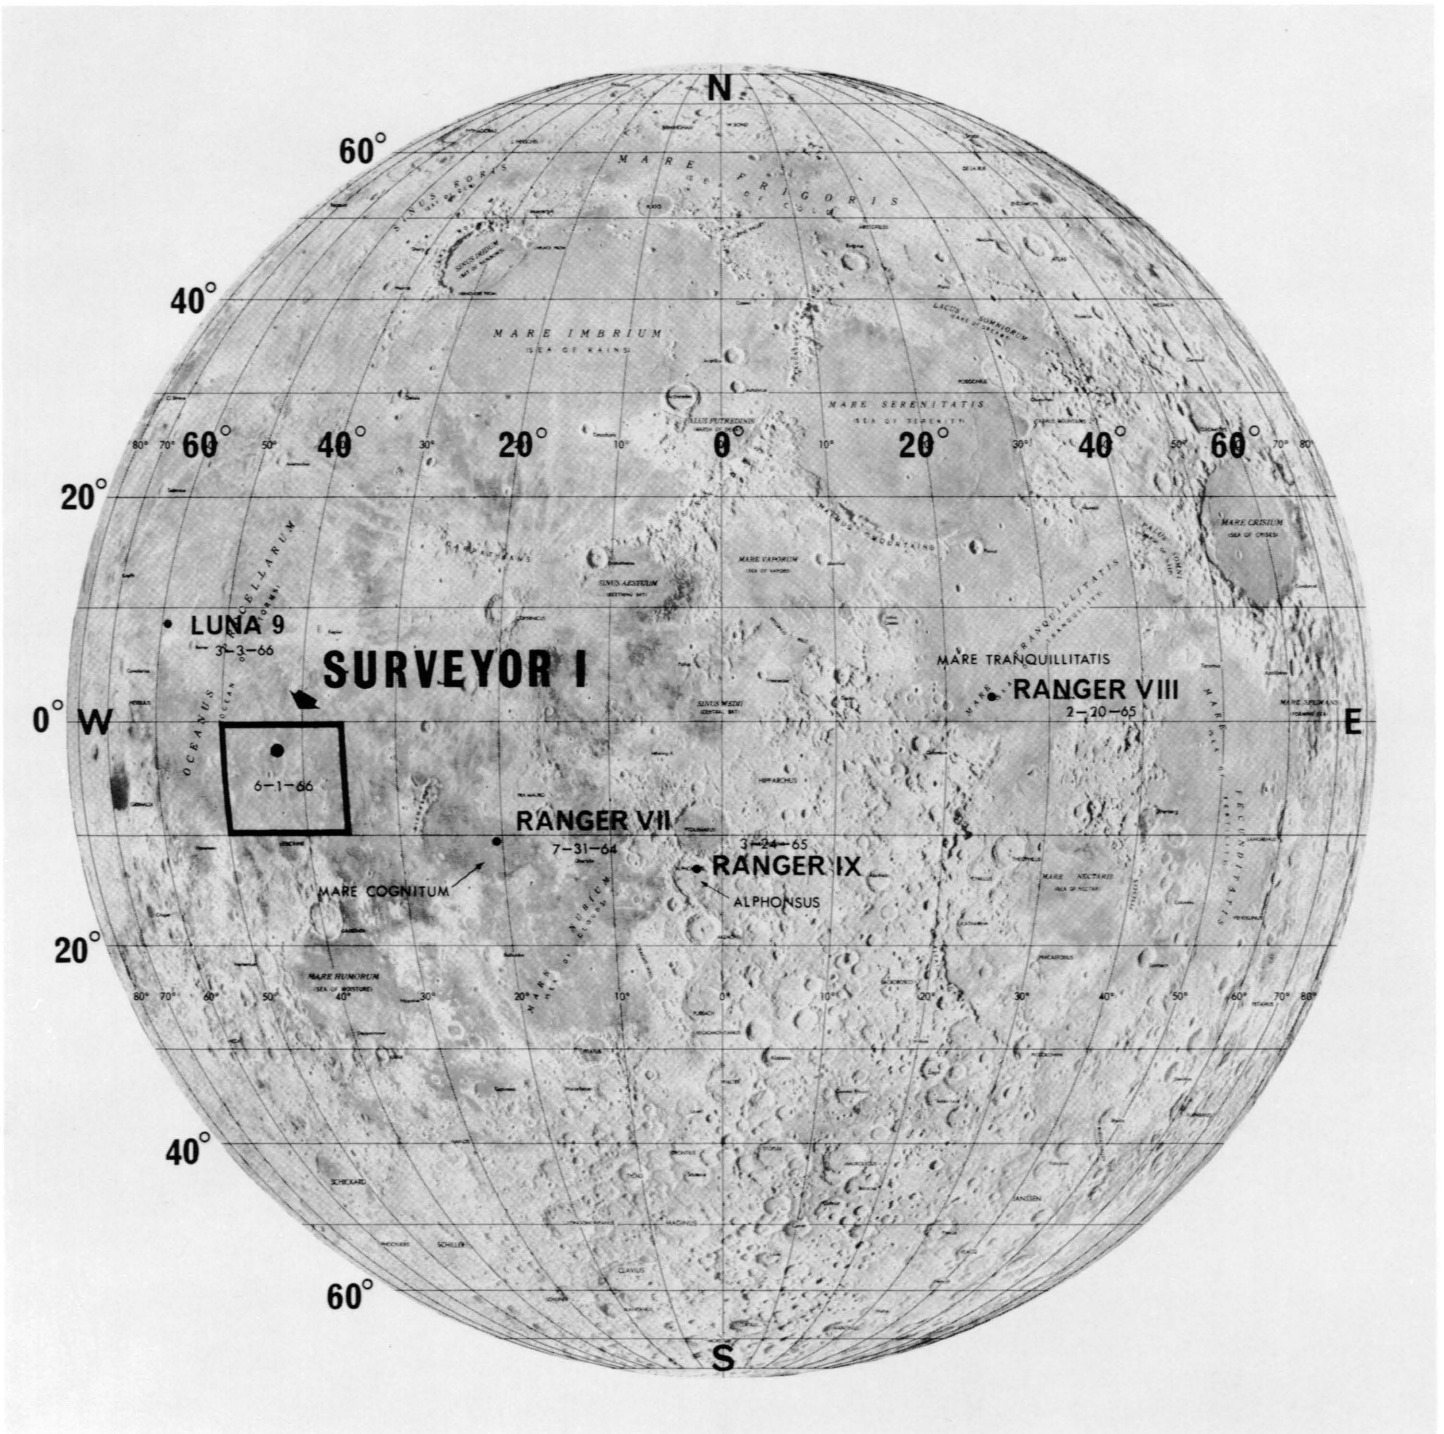
The landing sites of Surveyor I, of the lunar photographic spacecraft Rangers VII, VIII, and IX, and of Luna 9 are inscribed on this map of the lunar globe. Surveyor I made a perfect low-speed, three-point landing on the Moon on June 1, 1966, after a 63-hour, 36-minute flight from Cape Kennedy. During the following 12 days and 10 hours—before the Sun set on Surveyor's landing site in the Ocean of Storms on June 14—the spacecraft's survey television camera scanned and transmitted to Earth 10,338 high-resolution pictures of the lunar surface. The first picture was taken at 7 minutes before midnight, Pacific Daylight Time, on June 1. The final picture, recorded at 9:37 a.m. PDT, June 14, after lunar sundown, portrayed one of Surveyor's landing feet and the surrounding terrain, illuminated by earthshine only. In July, 1964, and in February and March, 1965, Rangers VII, VIII, and IX transmitted to Earth a total of more than 17,000 high-resolution pictures of the Moon's surface as the initial step in the United States' unmanned lunar exploration program. Surveyor I performed the first mission in America's second generation of Mooncraft. The Soviet Union's Luna 9 photographed the extreme western region of the Ocean of Storms after a successful landing in February, 1966.

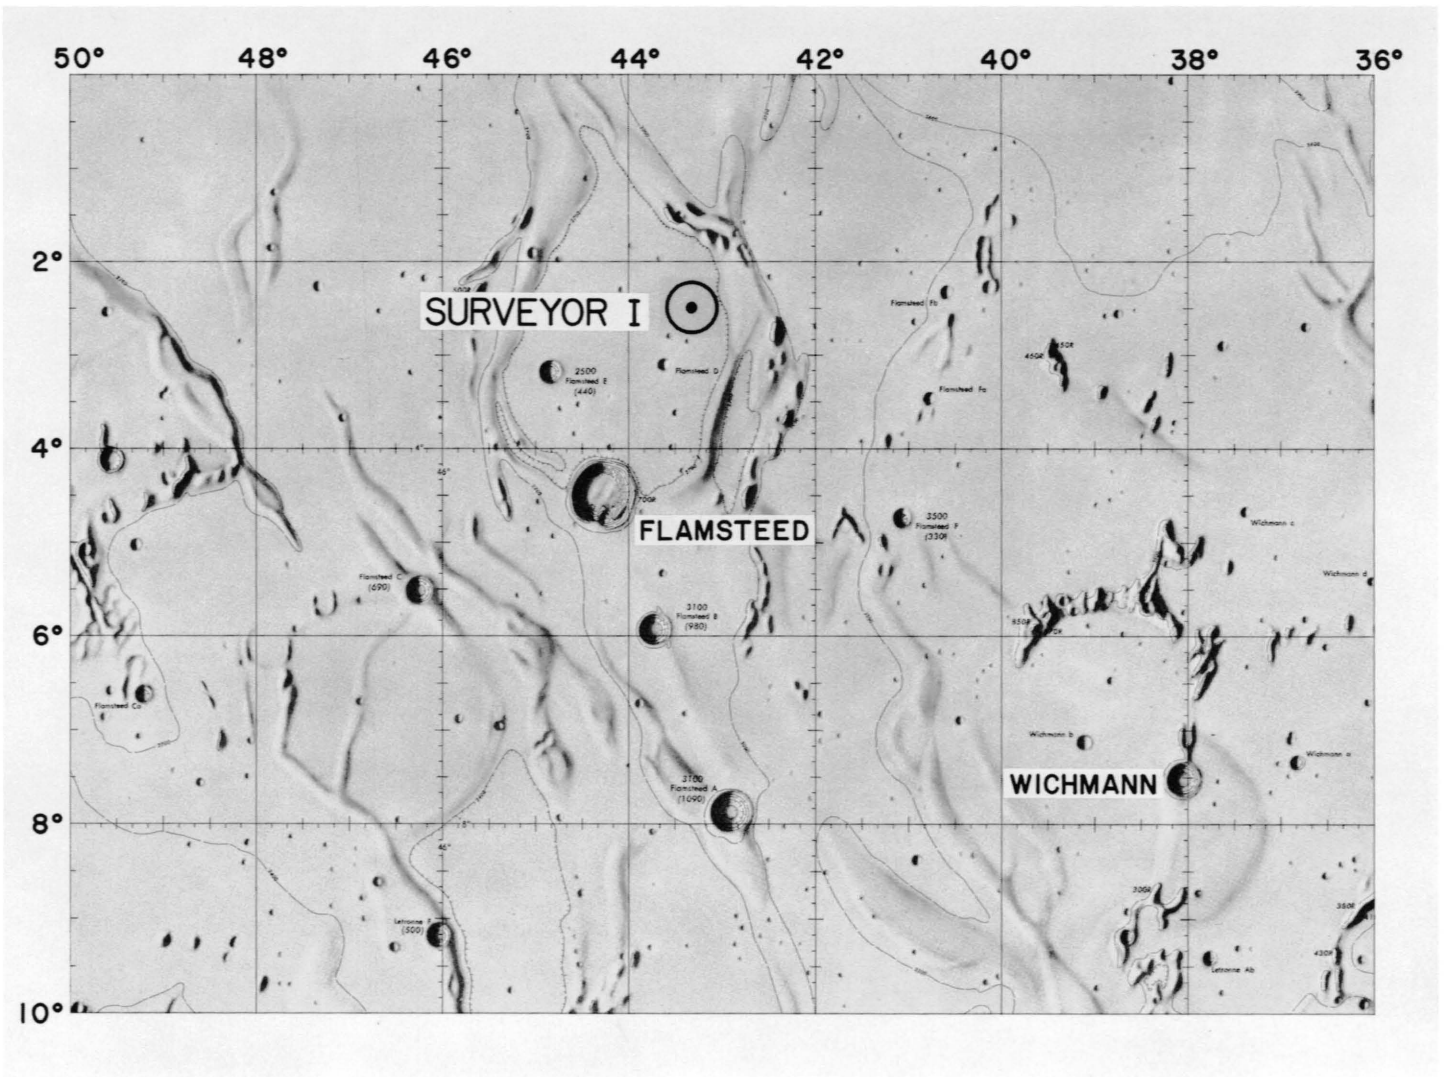
Surveyor I touched down gently on the Moon on June 1, 1966, at 2.356°S latitude and 43.36°W longitude, about 9 miles from its aiming point. The spacecraft landed at approximately 7.5 miles per hour, its three feet touching the surface within 19 thousandths of a second. Two “touchdowns” less than 1 second apart were registered by strain gages on the landing legs, indicating that Surveyor bounced about 4 or 5 inches. The landing site was a smooth area on the debris-filled floor of a “ghost” crater 60 miles in diameter within the Ocean of Storms. Part of the rim of the ancient crater can be seen as a distant mountain range rising beyond the horizon in Sheet 6. Thirty-seven miles to the south-southeast is a newer crater, Flamsteed. Latitudinal line at top of map is the lunar equator.

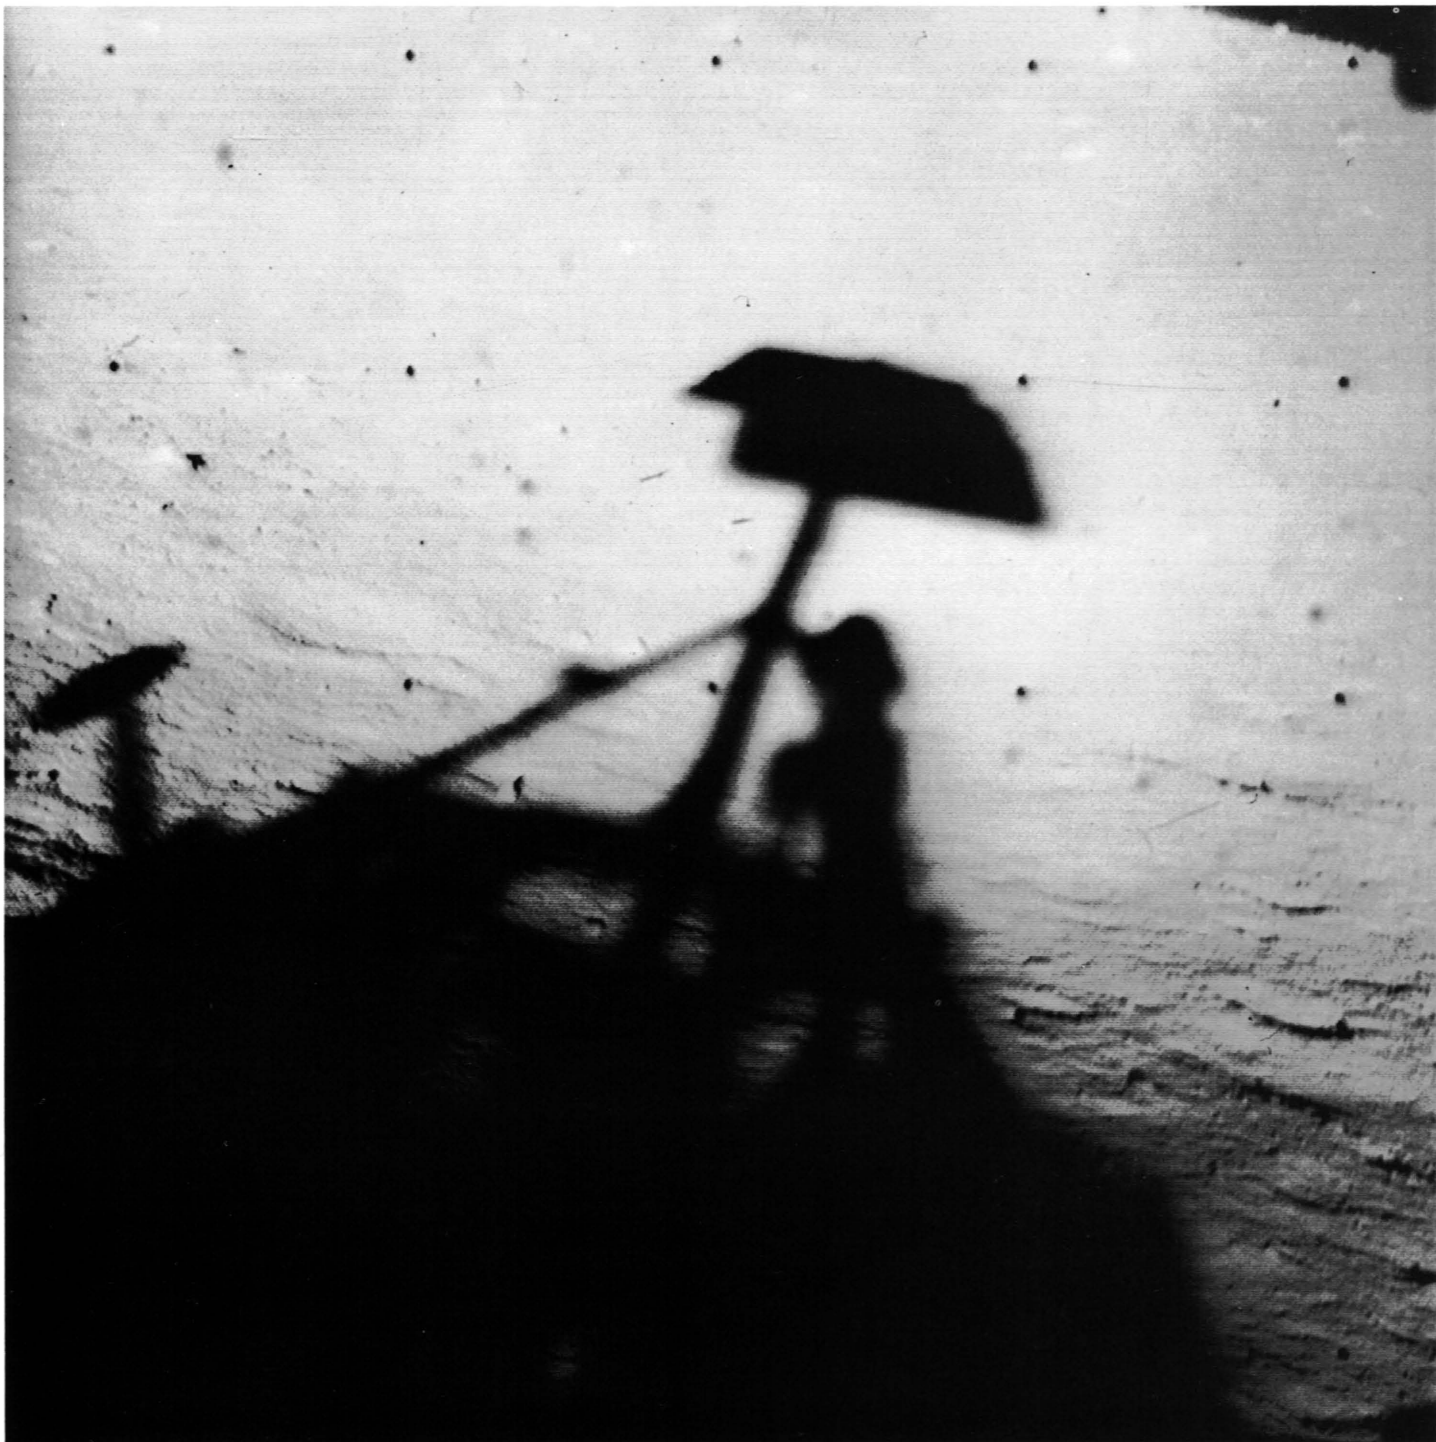
Lunar visitor Surveyor I took this picture of its own shadow against the Moon's surface in the back-lighting provided by the evening Sun. The wide-angle TV picture was taken by Surveyor's camera at 11:55 a.m. PDT, June 13, less than 24 hours before the Sun set on the landing site. The spacecraft's high-gain antenna and solar panel atop the mast, the camera at the right of the mast, and the low-gain antenna at the left edge of the picture are clearly silhouetted against the lunar surface. The regularly spaced black dots are reticle marks arranged on the face of the TV vidicon tube to indicate distortion if any exists. A portion of the horizon can be seen in the upper right corner.

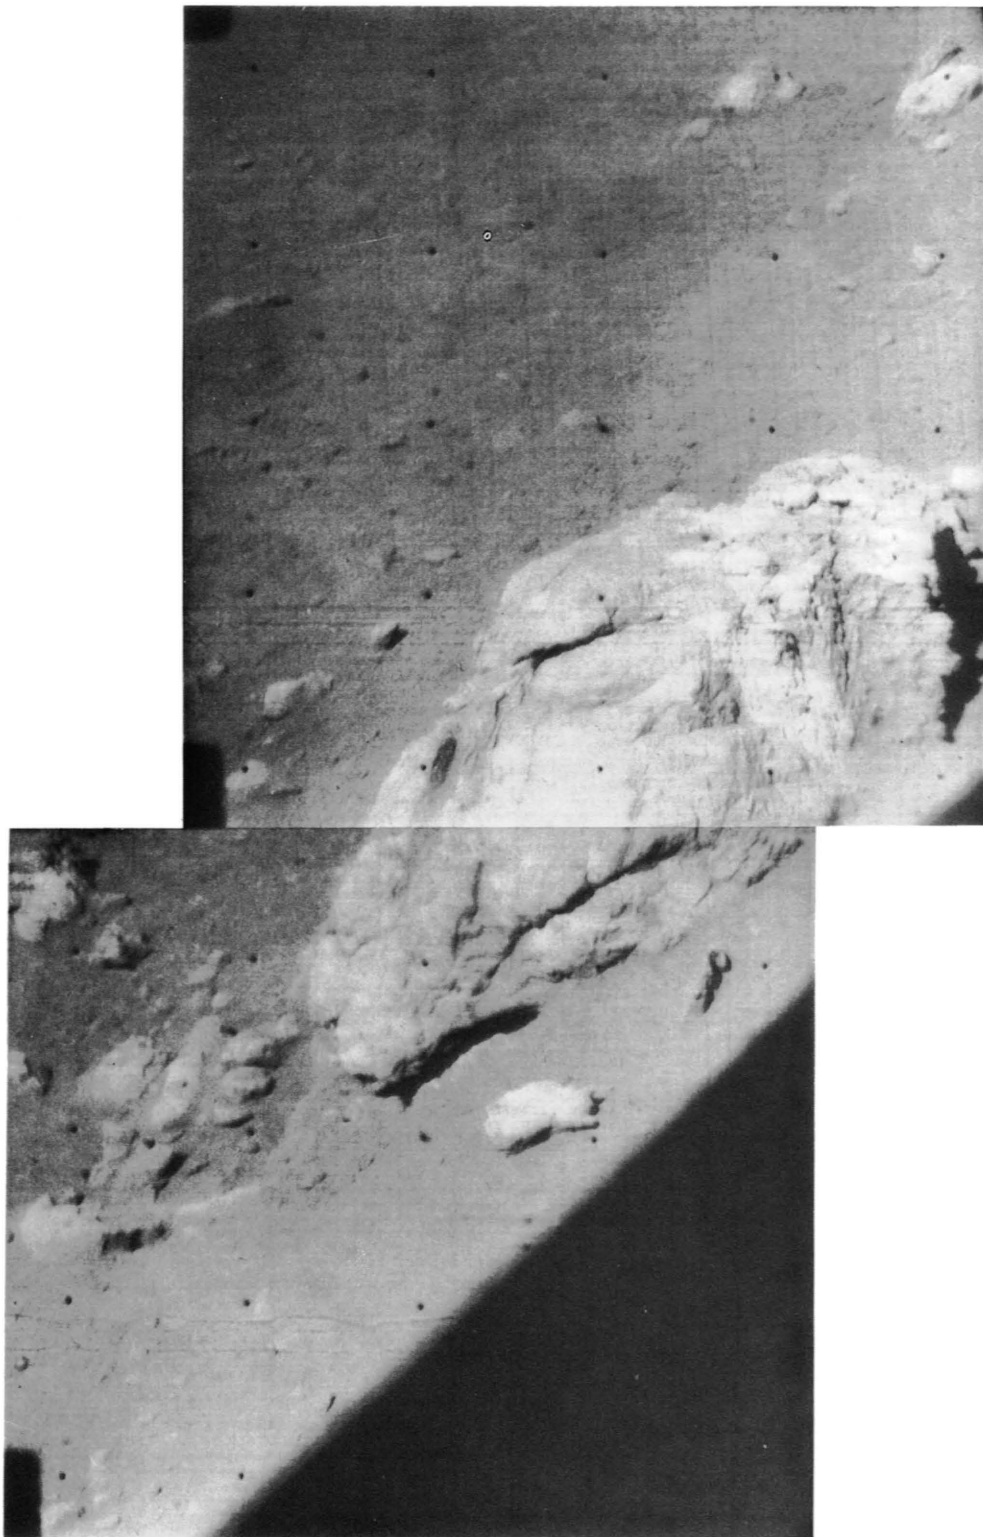
Composite of two narrow-angle pictures taken by Surveyor I on June 3 shows a Moon rock about 6 inches high and 18 inches long. The distance across the center of the top frame is 30 inches, across the bottom frame, 18 inches. The rock is about 12 feet from Surveyor's camera. The diagonal shadow at bottom right was cast by one of the spacecraft's electronics compartments. The bright rock above the shadow is about 1 by 3 inches. The rock fragments at left of the large rock range from several inches to $\frac{1}{8}$ inch in diameter.

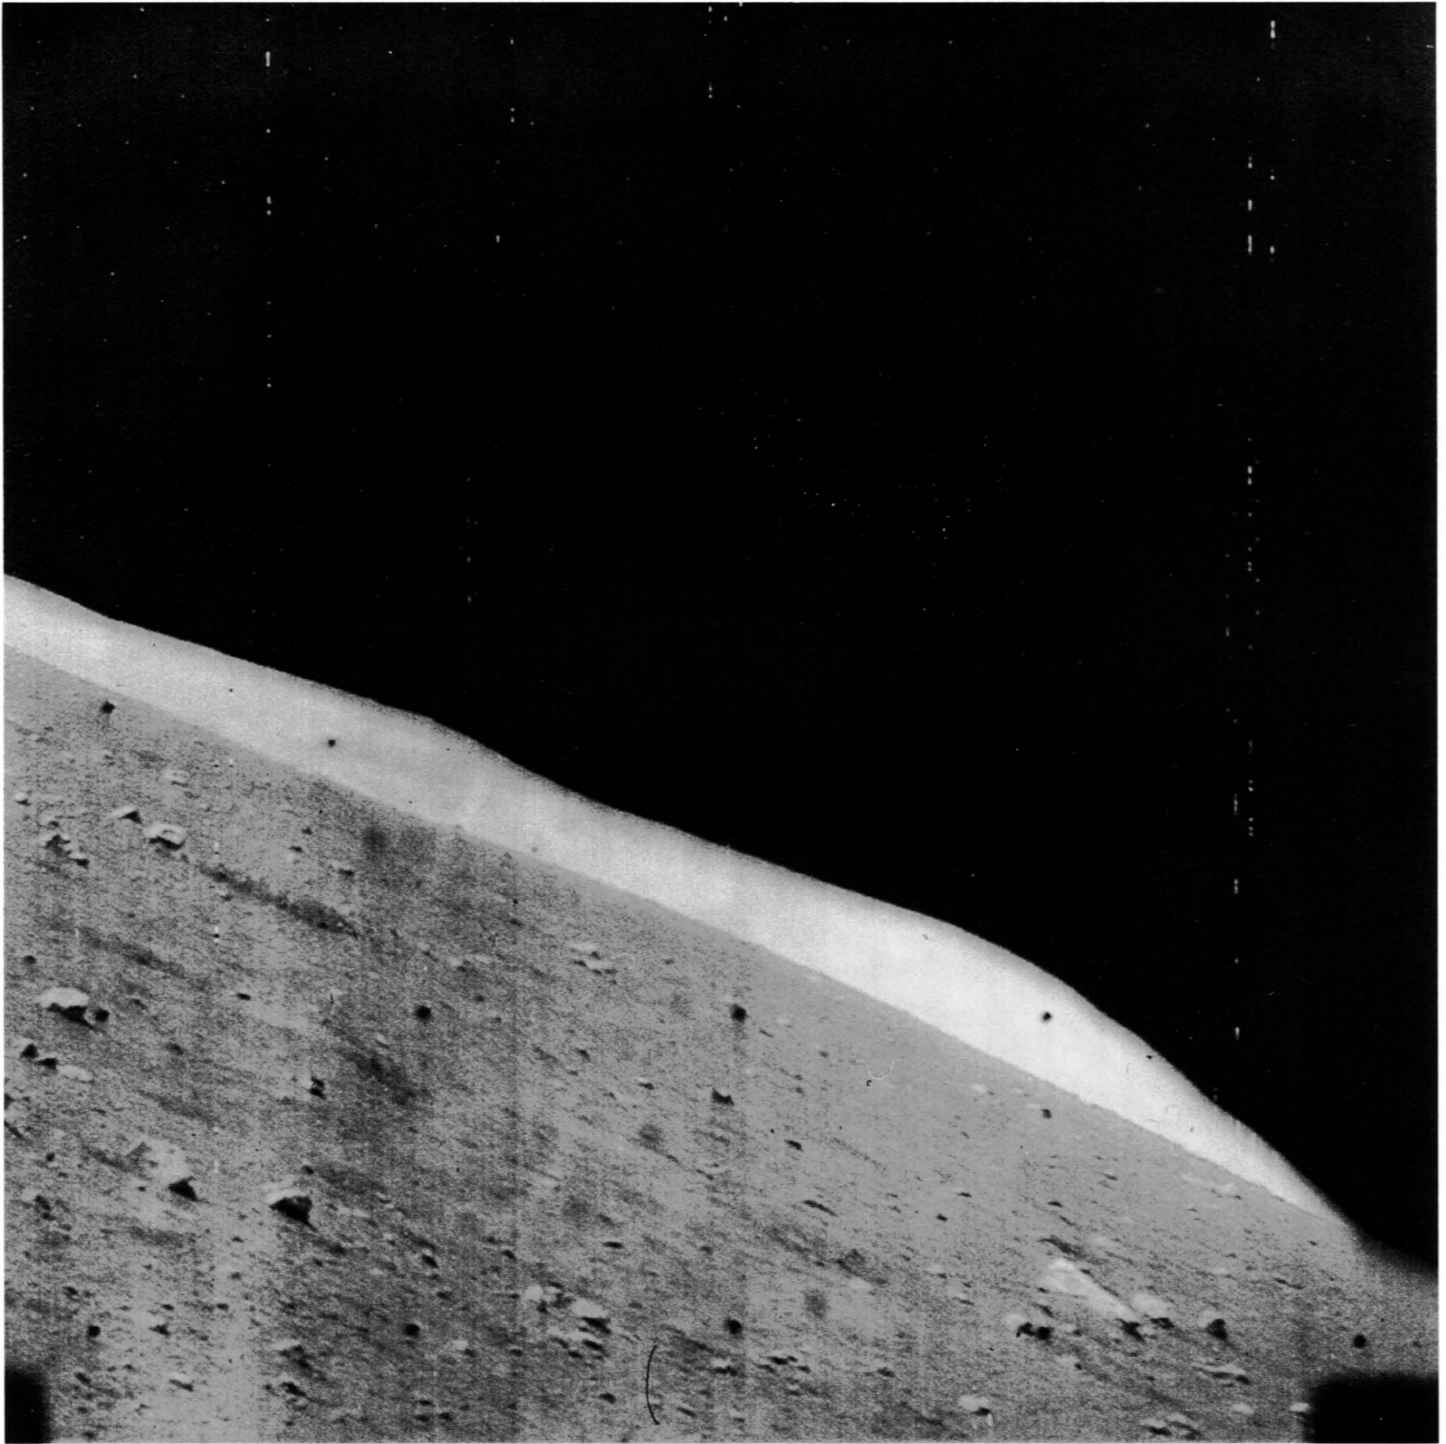
The crest of a small mountain range on the Moon, about 12 miles northeast of the landing site of Surveyor I, is seen in this narrow-angle picture taken on June 10. Only the top of the mountain shows above the near horizon, which is probably less than a mile away. The mountain, rising about 500 feet above the horizon, is part of the rim of a nearly buried ancient crater more than 60 miles in diameter. Parts of the rim can be seen from Earth with large telescope. Surveyor landed inside the "ghost" crater at 11:17 p.m. PDT on June 1.

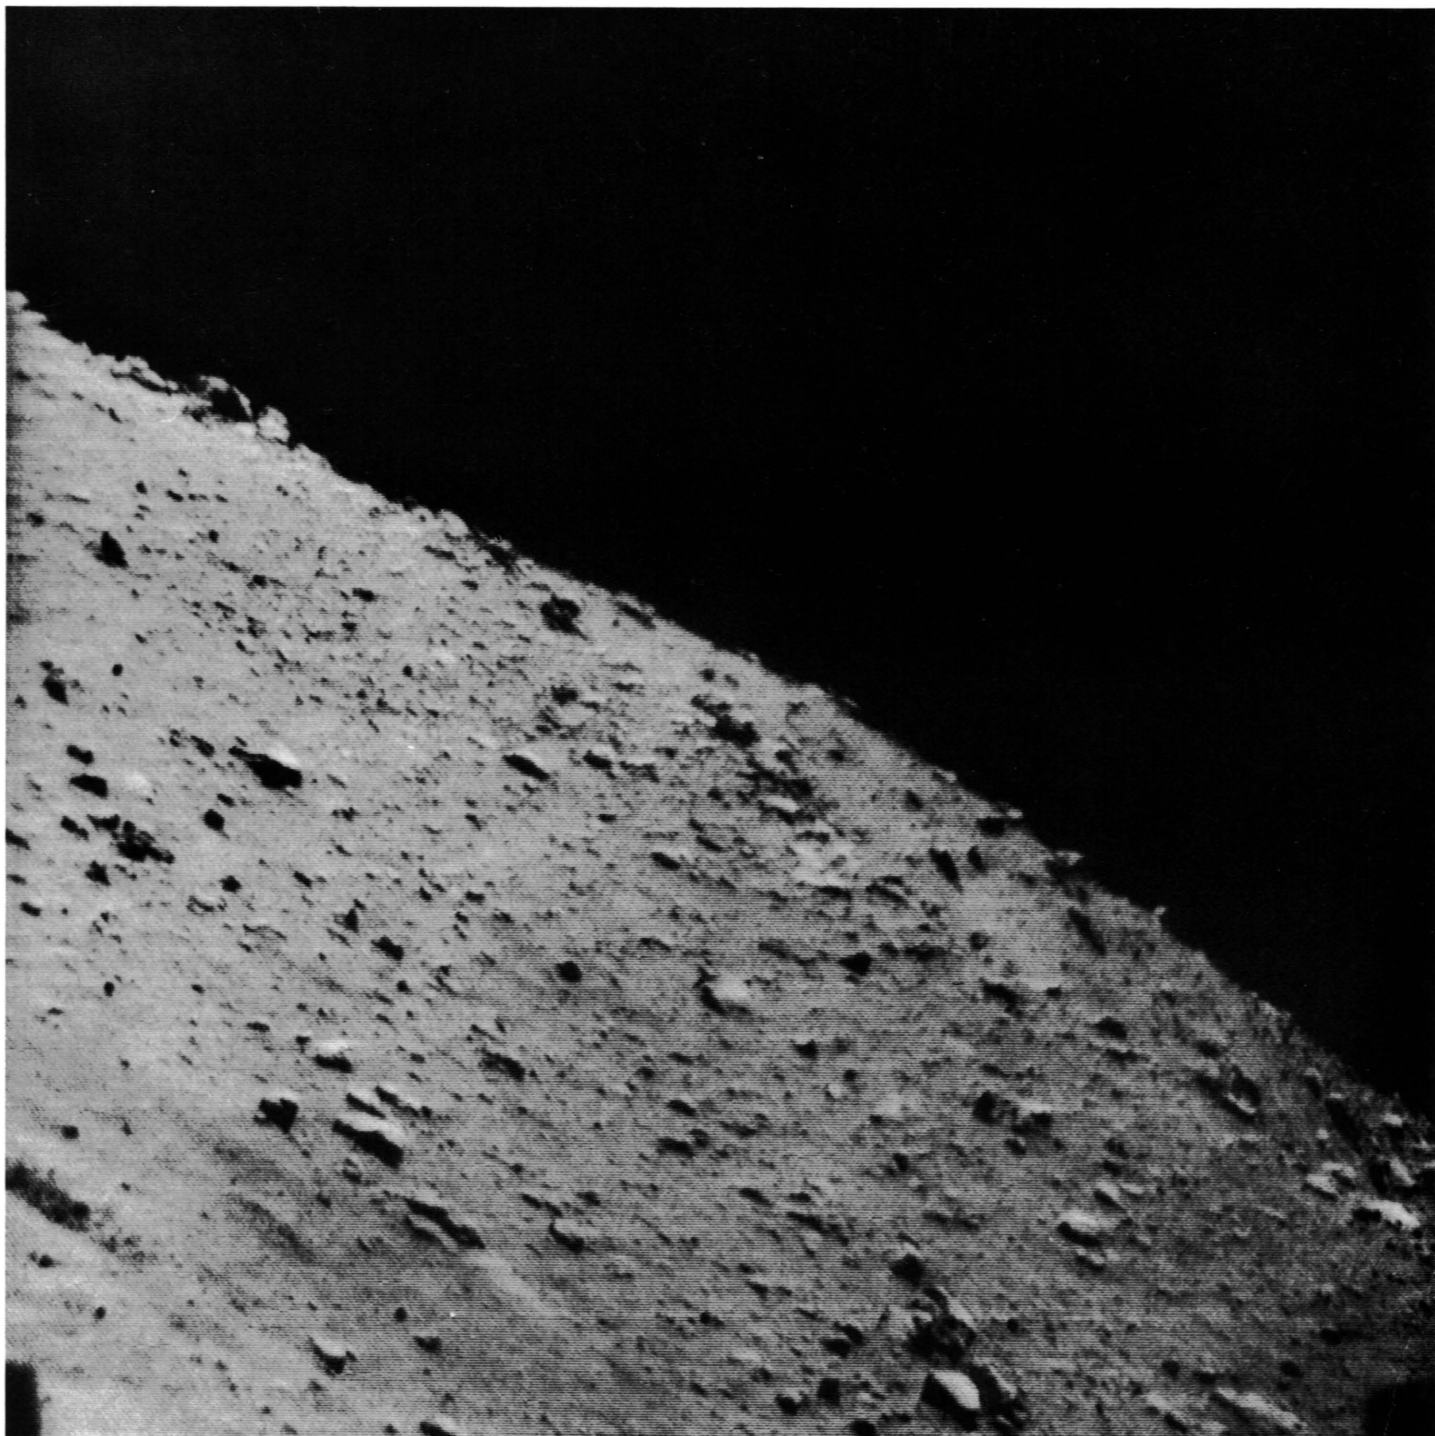
The boulder-strewn surface of the Ocean of Storms as seen by the television camera of Surveyor I shows the outside of a crater rim just right of the center of the horizon. The crater falls away beyond the horizon and to the right of the area covered in the narrow-angle picture. The photograph was taken on June 5, with the Sun almost overhead. The distance along the horizon is several tens of yards. The boulders on the horizon near the upper left may be 1 or 2 yards in length; the smallest rock fragments seen are several inches across. The rocks, which appear to be broken, solid material, apparently were scattered from the crater toward the site of Surveyor. The crater may be as large as $\frac{1}{3}$ mile in diameter. The camera was pointed slightly south of east on the Moon.

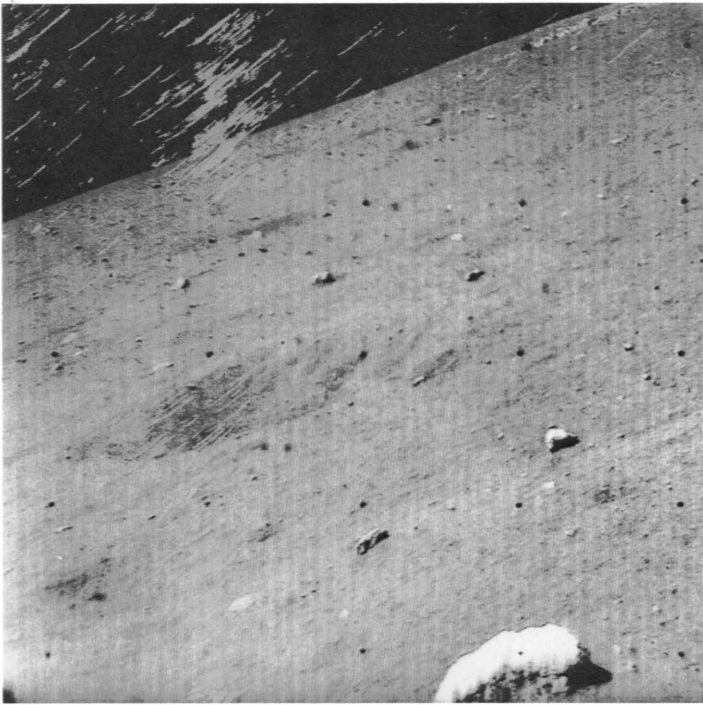
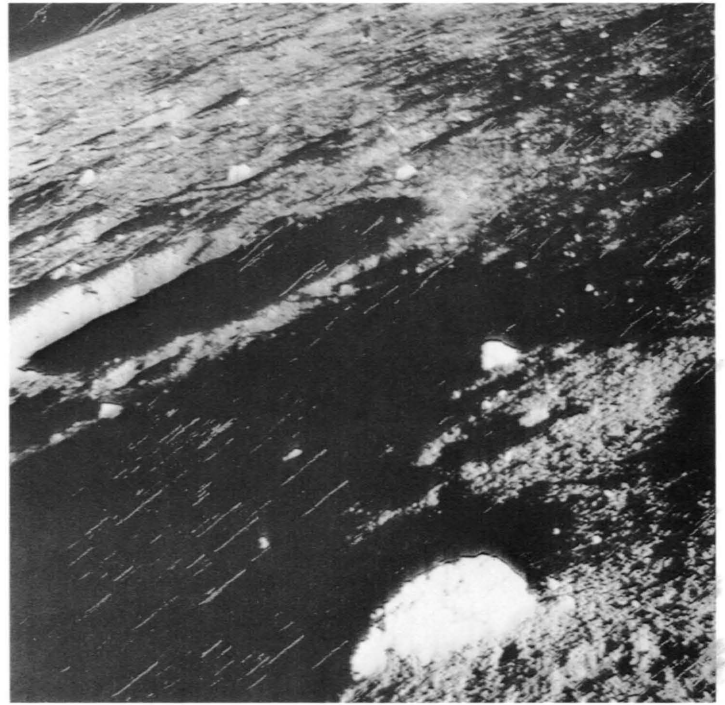
Two wide-angle Surveyor I photographs show a lunar scene—at nearly the same azimuth and slightly different elevations—taken 9 days apart. The effect of the Sun angles on the Moon features is evident. The picture at left was taken on June 5, 2 days before lunar noon; that at right just a few hours before sunset on June 14. The crater at left in both photos is about 10 feet in diameter and lies some 35 feet from the spacecraft. At the lower Sun angle (right photo), about 14 degrees above the western horizon, the far side of the crater is seen to have a raised rim. This feature is not evident in the accompanying picture. The rock in the foreground is about 6 inches high and 12 inches long. Both the crater and the rock can be located in the upper left of the mosaic panorama shown in Sheet 12.

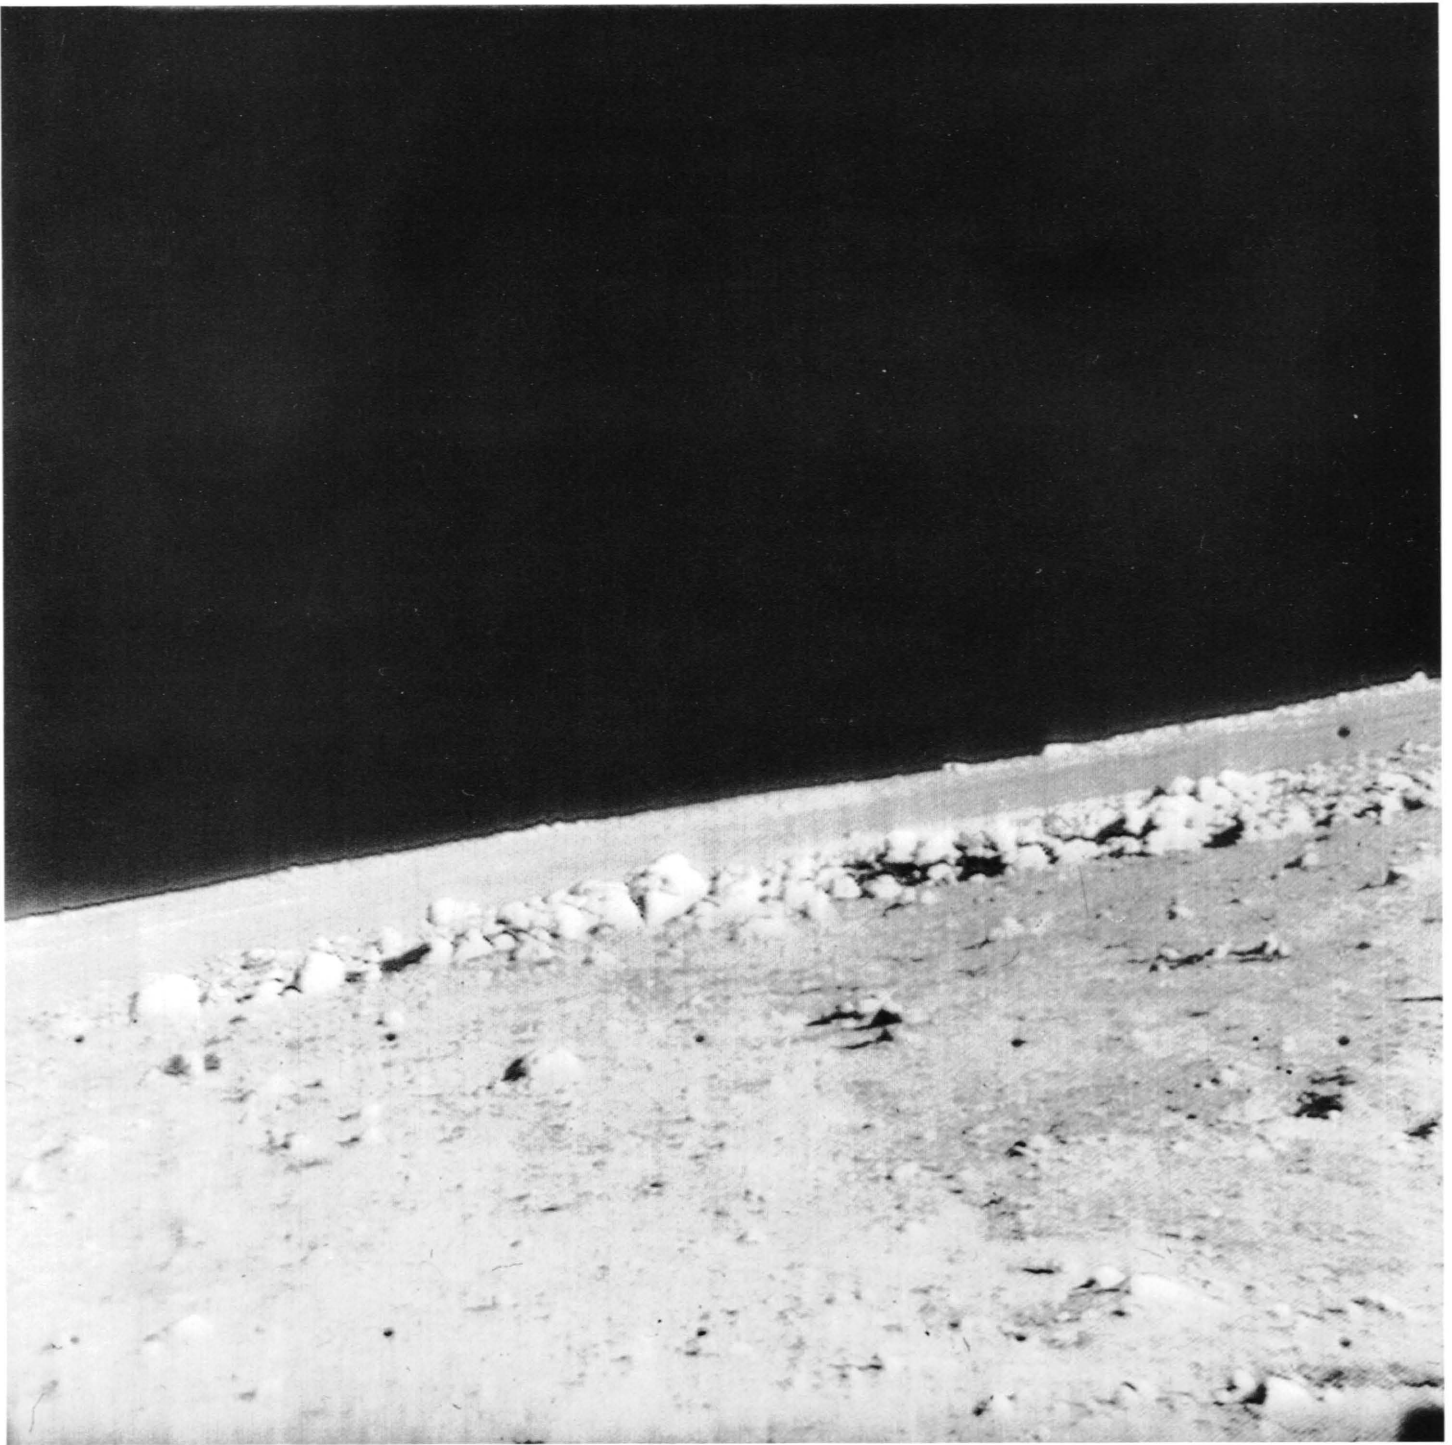
This narrow-angle photograph of the lunar horizon southwest of Surveyor's landing site was taken on June 13, about 24 hours before sunset. The line of large, rounded blocks marks the near rim of an ancient crater several hundred yards in diameter. The crater's far rim can be seen on the horizon.

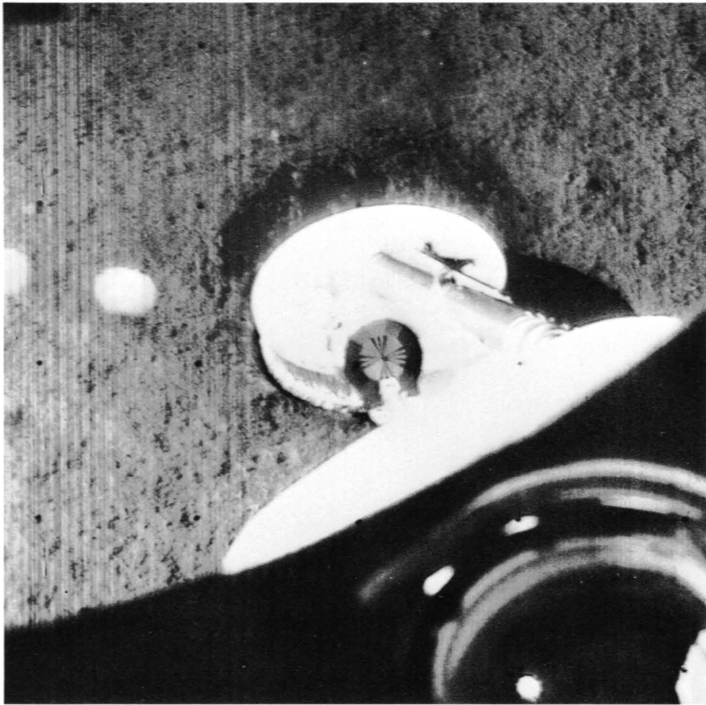
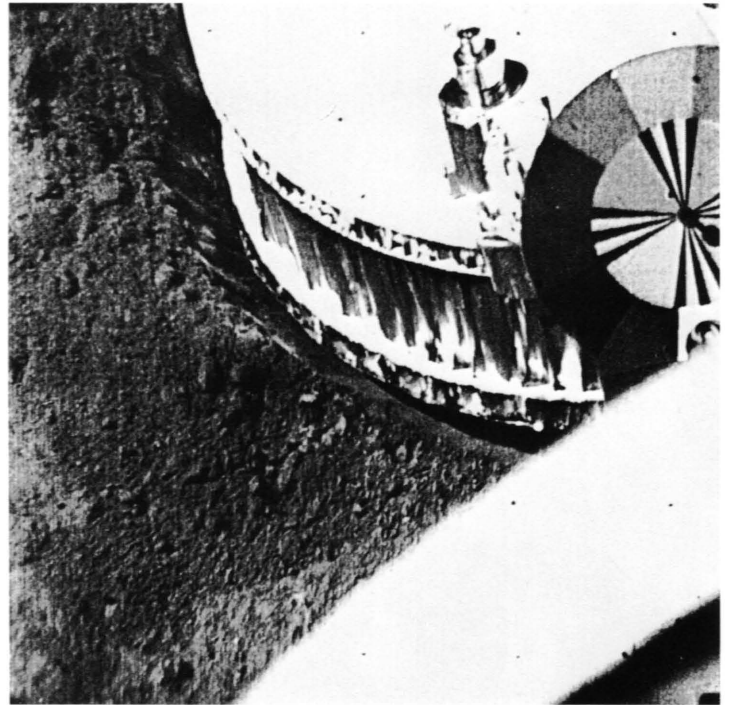
The photograph at the left is the first 600-scan-line picture taken by Surveyor 1 on June 2. It shows a landing foot resting on the Moon and the surface depression caused by its pressure as the spacecraft landed. Grains as small as $\frac{1}{4}$ inch can be resolved in the wide-angle photo. At right, the narrow-angle view of the same foot has a resolution of $\frac{1}{50}$ inch. Computer filtering of the original data accentuates the fine detail in the disturbed lunar surface as seen in the picture at right. The bright spots in the left picture are reflections of the Sun caused by elements of the camera lens. The dark rings in the lower right are reflections of the camera's filter wheel on the lens, as seen in the camera mirror. The small, dark wheel-like object visible in both photographs is a photometric color calibration target mounted on the landing foot. The attitude-control jet, at left of the calibration target in the computer-enhanced picture, is nearly invisible in the left picture.

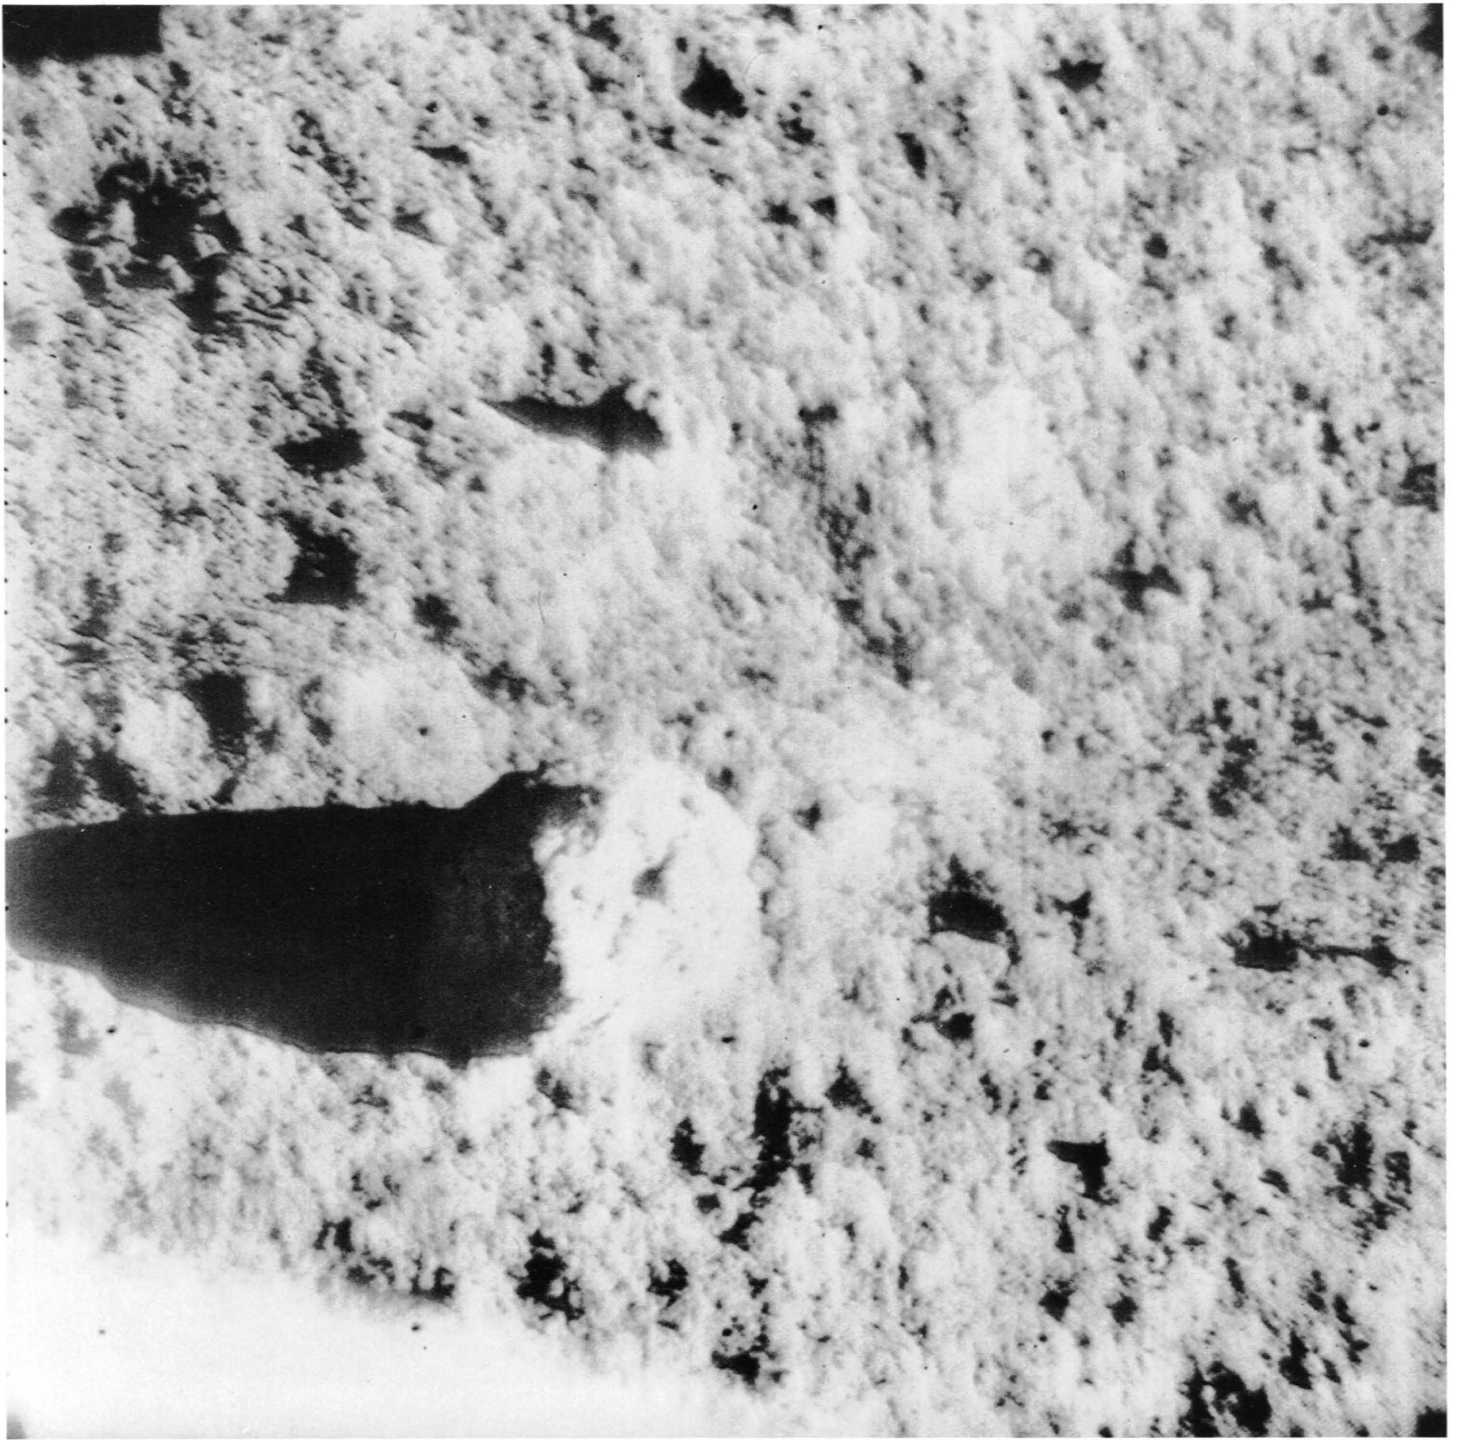
A close-up photograph taken at low Sun illumination near the Surveyor I spacecraft shows the cratered and lumpy textured lunar surface. The block casting a long shadow is several centimeters wide. The narrow-angle picture, transmitted to Earth on June 12, is one of more than 10,000 pictures taken by Surveyor I before sundown, June 14.

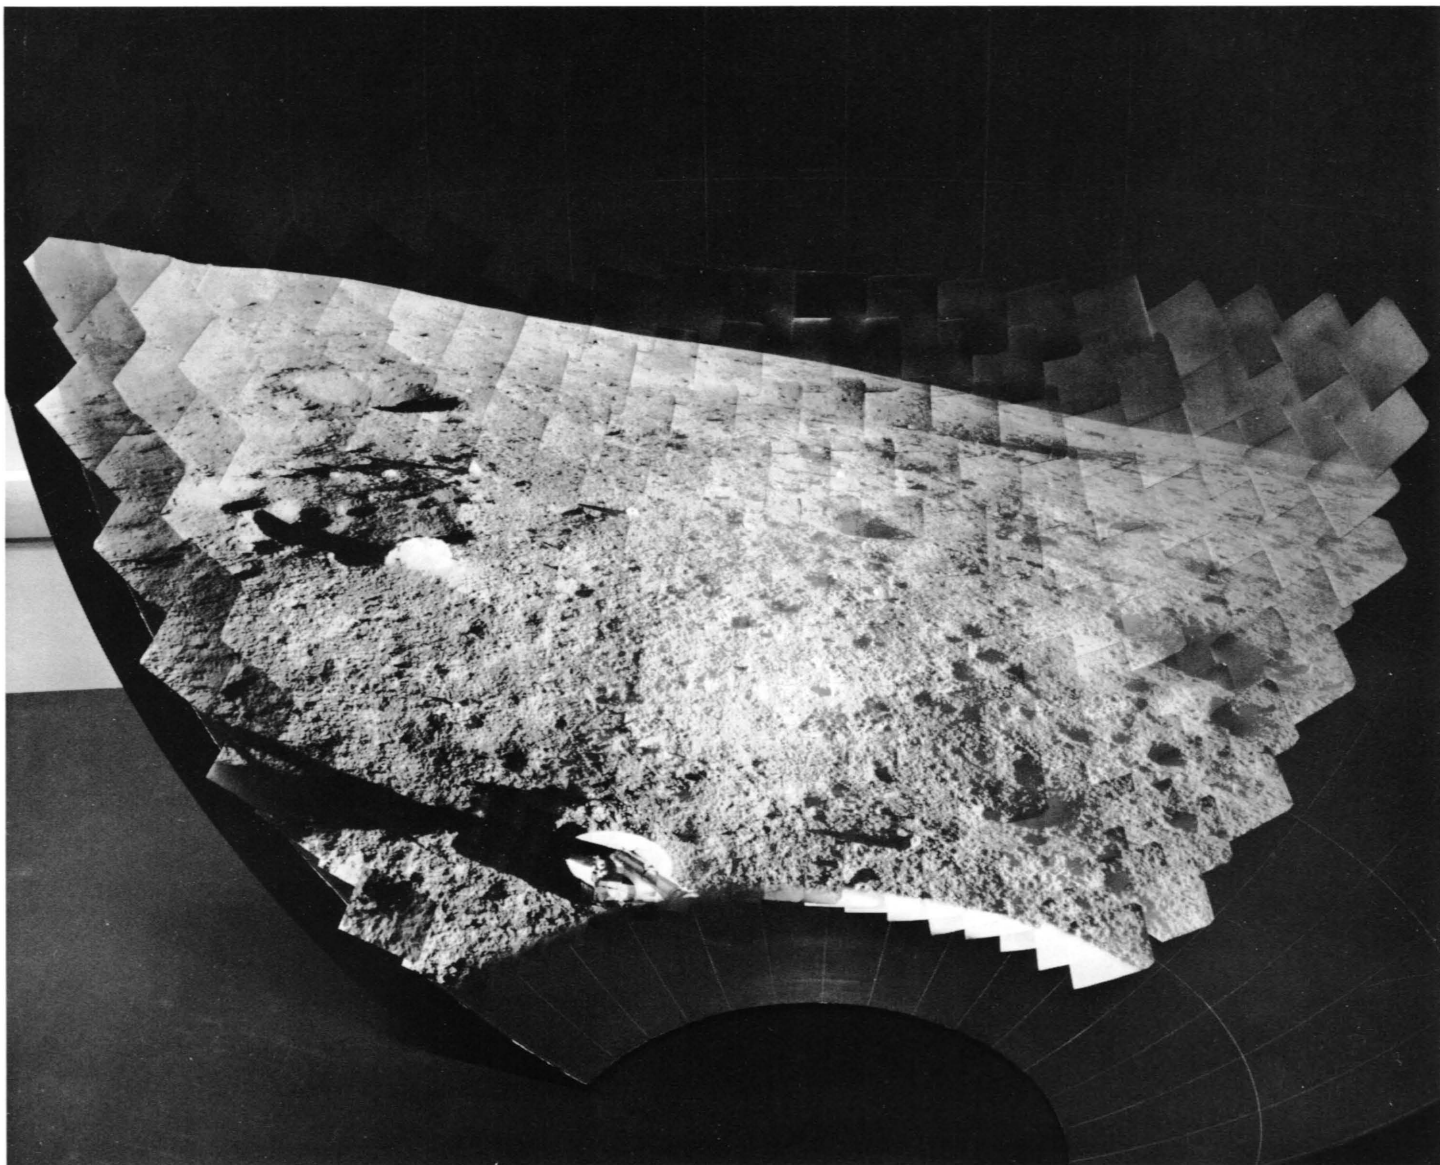
A spherical mosaic of narrow-angle pictures of the Moon taken by Surveyor's television camera forms a panoramic view of the lunar terrain, stretching approximately 130 degrees across the horizon. Each photo chip is 2 inches square and represents a 6-degree field of view as seen by the camera. The pictures are mounted in overlapping fashion against the concave surface of a 3-foot hemisphere. The survey was made on June 13, about 24 hours before the Sun set on the pictured site.
